Service Letter: 442 Revision A

Date: August 18, 2017

Title: Inspection of Aileron Hinge Rib and Support

Models: 8KCAB serial numbers 1116-2012 to 1120-2012 and 1122-2012 to 1170-2017  
8KCAB any serial number equipped with 4-2142 exposed balance ailerons

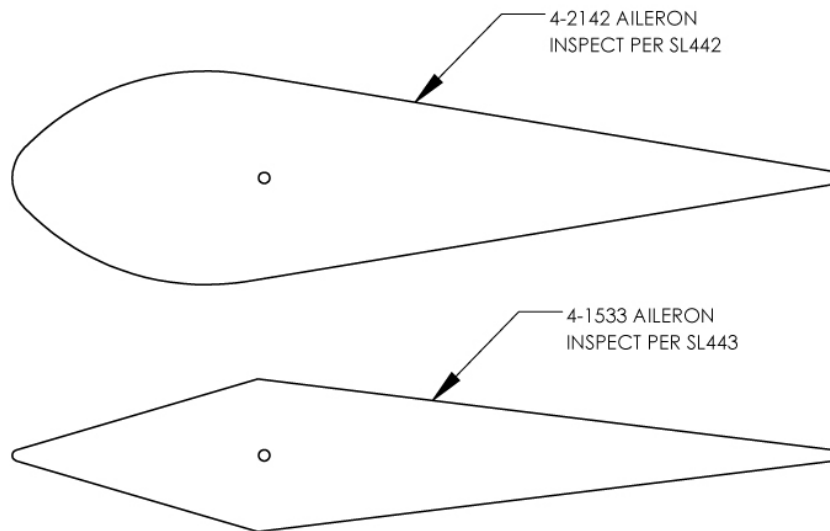
**Figure 1, Aileron Part Numbers**

Affected airplanes can be identified by visually comparing the installed aileron to Figure 1. Reference SL443, initial rev., dated 8-18-2017 or later approved revision for aircraft equipped with the standard 4-1533 aileron.

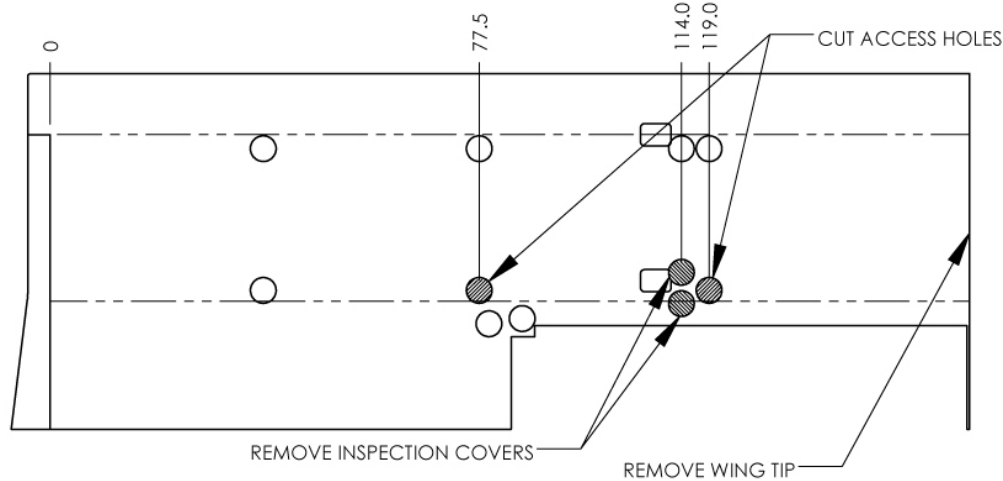
**Figure 3, Wing Inspection Locations**

3. Open access holes on the bottom of the wing at stations 77.5 and 119.0 as measured from the wing butt rib (2 locations per wing). The access holes are shown in Figure 3. Opening the access holes is optional provided an equivalent inspection can be conducted (i.e. borescope).
4. Remove inspection covers located on the bottom of the wing at station 114.0 per Figure 3.

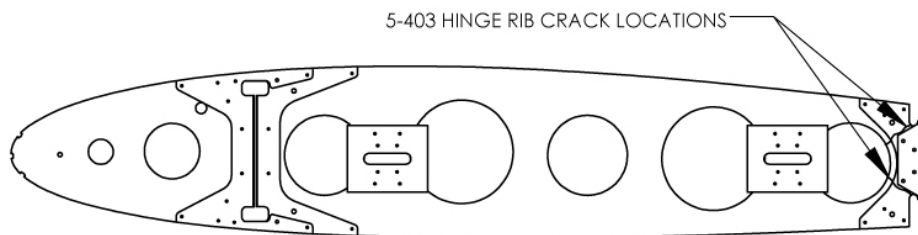
**Figure 4, Hinge Rib Crack Locations**

5. Visually inspect hinge rib and rear spar gusset for cracks as shown in Figure 4 (3 locations per wing). The cracks originate at the rear spar relief and propagate diagonally toward the rib lightening hole. The cracks may also originate from rivet locations. Using a mirror inspect the opposite side of the hinge rib and gusset for cracks.

8. If cracks are found repair per Service Letter 444, initial rev., dated 8-18-2017 or later approved revision.
9. American Champion requests a report of the initial inspection. Please include the following information via email to [aca-engineering@tds.net](mailto:aca-engineering@tds.net) or phone 262-534-6315:

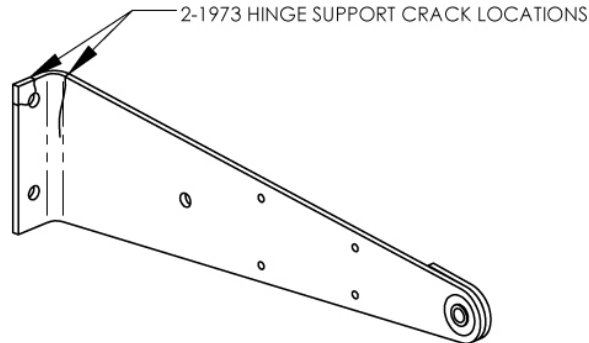
**Figure 5, Hinge Support Hinge Locations**

6. Visually inspect hinge support for cracks as shown in Figure 5 (2 locations per wing). The cracks may originate from the upper or lower edge of the support and propagate along the bend line. Inspection should also include the bolt locations at the rear spar. Use a mirror to inspect opposite side of the hinge supports. Inspection of the opposite side of the middle hinge support is difficult but possible by locating the mirror above and immediately outboard of the support.
