American Champion Aircraft Corp.
Rochester, WI 53167

Service Letter: 406 (page 1 of 3) Revision A

Title: Wood Spar Inspection

Models: All Model 7's, 8's and 11's with wood spar wings

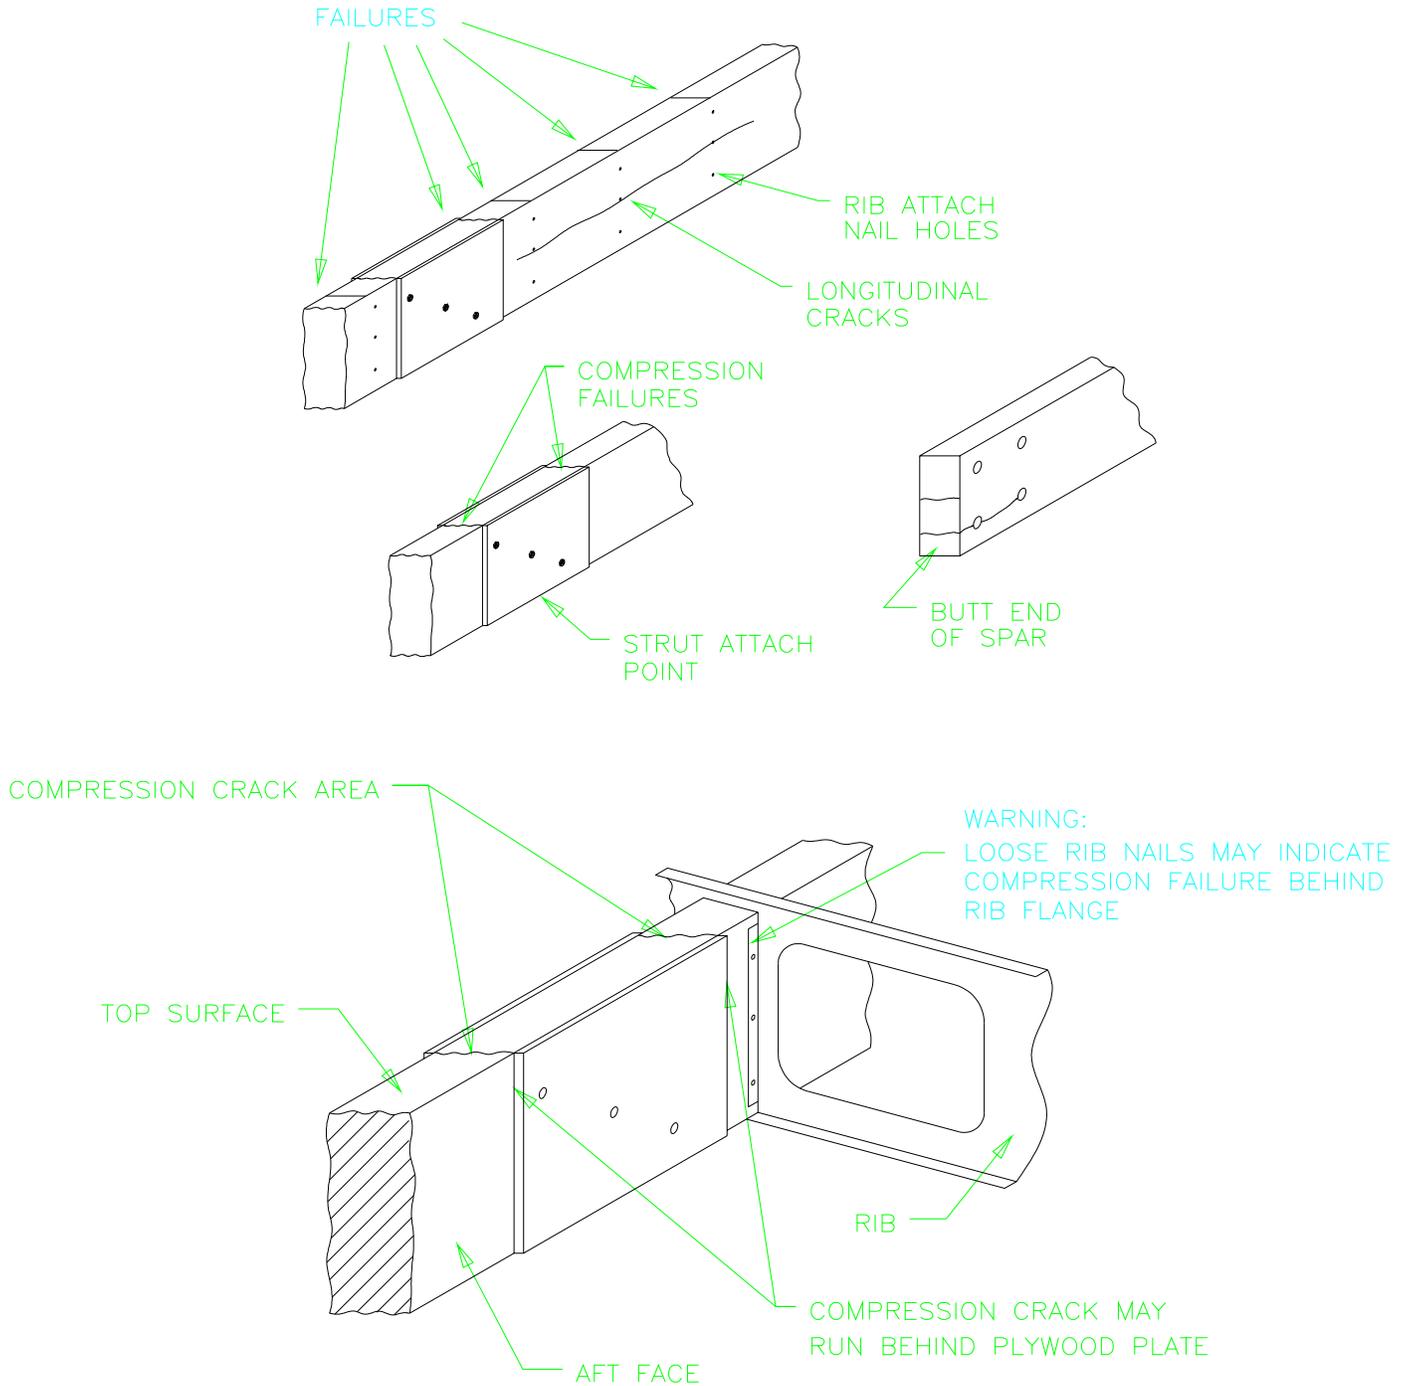
Figure 1 Crack Location

Description: There have been reports of cracks developing in wood spars, both front and rear. There are many possible causes to the cracking including: high flight time, wing damage history, high acrobatic time, over-stress history, or having been exposed to changes in humidity over several years. Compression cracks have been found emanating from the upper and lower surfaces of the front and rear wing spars at both ends of the reinforcement plate for the lift strut attachment. Longitudinal cracks have been reported in all areas of both front and rear spars, including through the wing root. See figure 1 for example locations of spar cracks.

Inspection: The only area where it is possible to positively identify a compression crack is on (Bottom/Top) the top and bottom surfaces of the spar. Both front and rear spars need to be inspected. The key areas to be concerned with are shown in figure 1. Additional inspection holes may be necessary to do a thorough inspection. Service Letter 417, Revision C, may be used as a guide for installing additional inspection holes.

Instructions: If any damage was found in above inspections, it requires that the spar be repaired or replaced. Minor chafing and small indentations are not cause of rejection. Spar repair shall be accomplished in accordance with AC 43.13-1A Acceptable Methods, Techniques and Practices or other Federal Aviation Administration approved data.
