American Champion Aircraft Corp.  
Rochester, WI 53167

Service Letter: 430, Revision A

Date: March 05, 2008

Title: Conversion of 7ECA, 7GCAA and 7GCBC to Lycoming O-320-B2B or Equivalently Provisioned Engine per TCDS E-274.

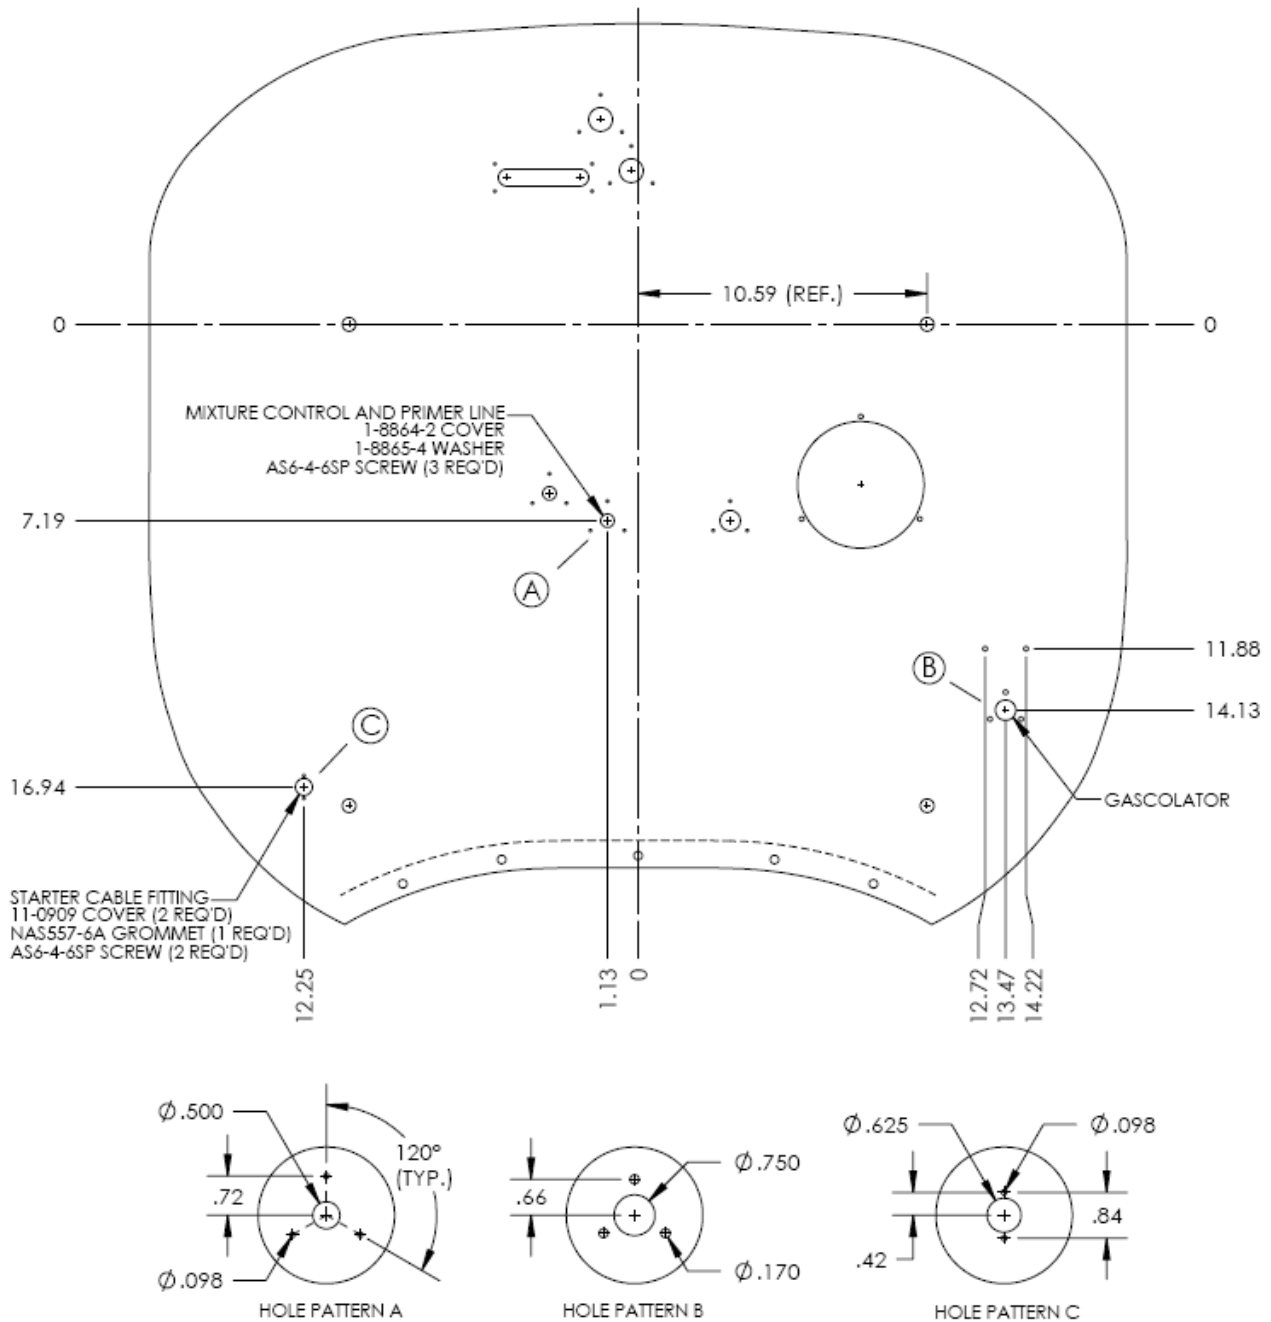
Figure 1, Firewall Modifications

Replace and relocate gascolator. See figure 1 for correct placement of the new gascolator. Replace carburetor fuel line with Aeroquip hose 624000-8D-0154. Replace fuel valve bracket with 11-0831 per ACAC drawing 7-1290. Components from the gascolator to and including the fuel manifold must also be replaced; install components per ACAC drawing 7-1476.

The existing 4-1640 firewall must be modified with the addition of the three hole patterns shown in figure 1, or replaced with a new 4-1640-4 firewall. Plug any unused holes with 1-8864-6 cover, 1-8865-4 silicone washer and AS6-4-6SP screws.
