Service Letter: 434

Title: Door Release Pin and Ring

Effectivity: 7ECA, 7GCAA, 7GCBC, 7KCAB, 8KCAB, and 8GCBC models manufactured before July 1, 2011 as indicated by the aircraft data plate. Aircraft manufactured after July 1, 2011 comply with this service letter.

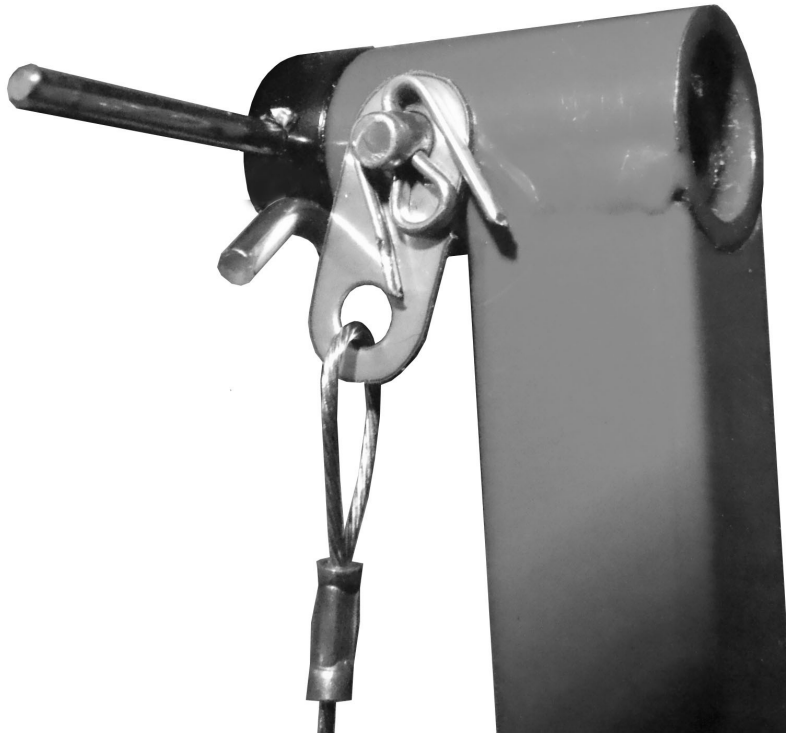
Figure 1, Installation Lanyard Tab

Description: Inadvertent removal of the door release pin and ring from the emergency door release handle is possible especially when entering or exiting the front seat of the airplane. There are two known service difficulty reports where the emergency door release pin and ring have become dislodged and partially jammed a flight control. This service letter provides a means to tether the pin and ring to the emergency door release handle.

1. Remove and discard current door release pin and ring.
2. Remove cotter pin securing MS20392-1C17 clevis pin. Clevis pin may be reused or replaced as necessary.
3. Install tab of 2-2352 lanyard assembly on MS20392-1C17 clevis pin. Secure with AN380-2-2 cotter pin as shown in figure 1.
4. Install door release pin through fuselage bushing and handle assembly as shown in figure 2.
