Service Letter: 417 (page 1 of 2) Revision C

Title: Installation of Inspection Covers for Wood Spar Inspection

Applicable Models: All Model 7's, 8's and 11's with wood spar wings
[Model 8KCAB has special instructions, contained herein.]

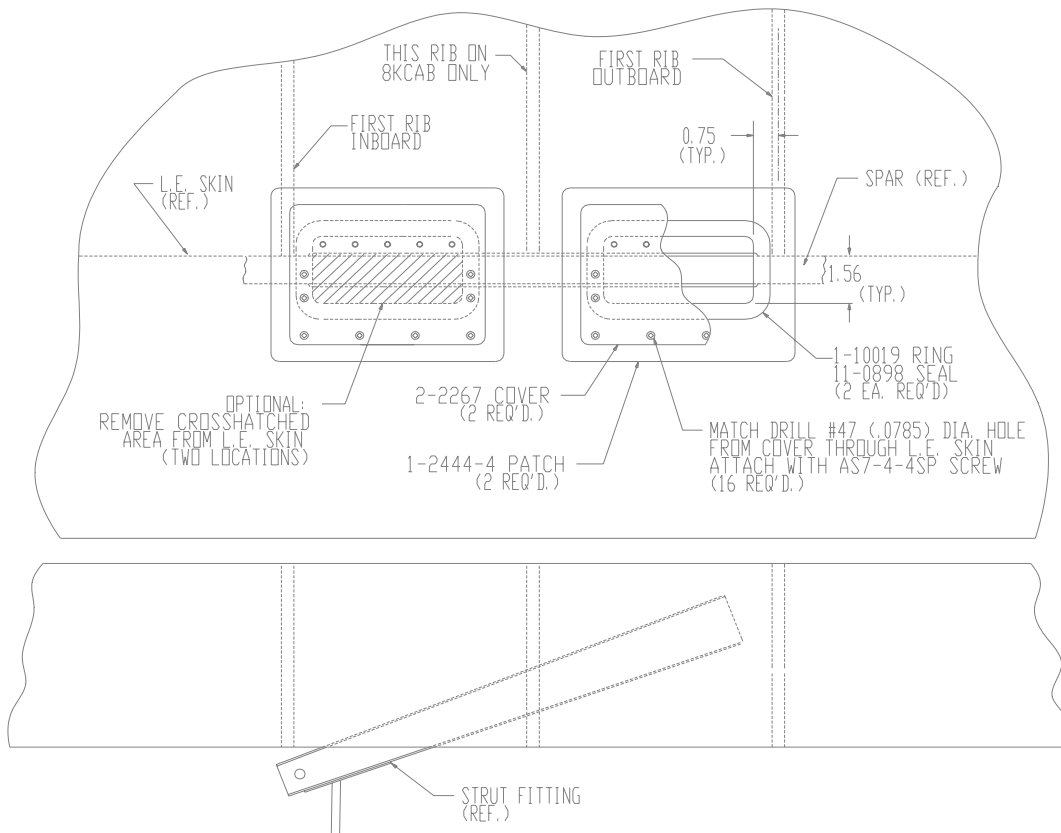
Figure 1 Cover Installation

To install optional removable covers for repeat inspection of the top of the front spar, two inspection holes and covers may be installed on the top side of the wing per Figure 1. Locate the positions of the 1-10019 acetate rings per the figure. Clean and sand the affected area down to the primer. Glue down the 1-10019 acetate rings and 1-2444-4 fabric patches with compatible fabric glue. Allow the glue to dry before cutting. Lightly iron the area, if necessary. Remove the fabric inside the ring. If deemed necessary for further inspection, the section of leading edge skin inside the acetate ring may be removed as well.

(continued) After inspection per service letter 406, paint covers and area as necessary. Install the 11-0898 rubber seal over the top of the acetate ring with a 3M™ 08008 weatherstrip adhesive or equivalent. While the adhesive is curing, weigh down the ring to make it as flush as possible. The 2-2267 covers can be installed by sliding the retaining tab under the acetate ring as far aft as possible. Using the cover as a guide, carefully match drill #47 pilot holes for the AS7-4-4 blunt screws

Debur the holes; reinstall the cover and attach the cover to the leading edge skin with eight AS7-4-4 blunt sheet metal screws. Optionally, the four leading edge screws in each cover can be replaced with CR3213-4-1 Cherry Rivets by first match drilling with a #30 drill.

Note: When drilling holes or installing screws, temporarily place a steel sheet metal shield over the spar area being worked on. Make the shield such that it is removable through the inspection hole on the bottom of the wing. A bend put into the shield will prevent it from falling onto the nose rib side of the spar. Remember to remove after inspection
